Where the Macadam Ends and the Dirt Begins, Kenosha, Wis.

BULLETIN NO. X.

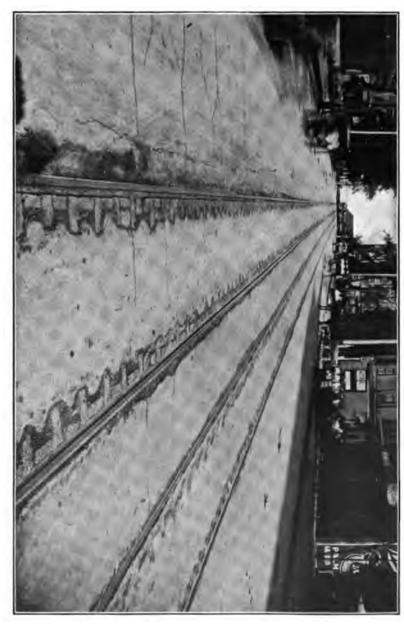
Asphalt Pavement. Wisconsin Street, between Jackson and Van Buren Streets, Milwaukee, Wis.

Shows manner in which this pavement wears next to the rails.

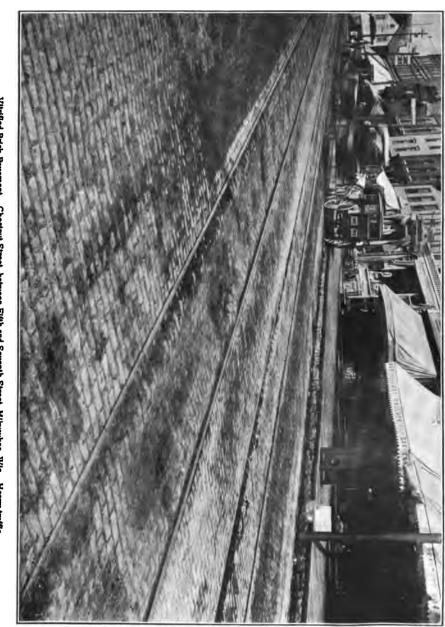
Vitrified Brick Pavement. Chestnut Street, between Fifth and Seventh Street, Milwaukee, Wis. Heavy traffic,
Two years old when photographed.

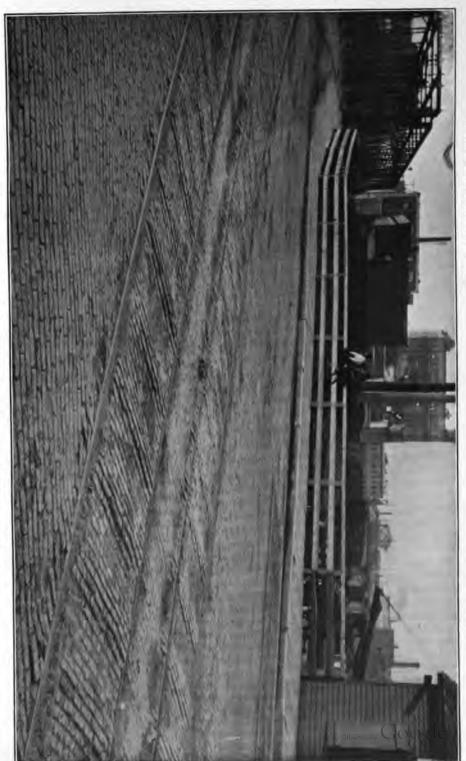
Brick Pavement. North of Main Street Bridge, Racine, Wis. Result of not embedding ties in concrete.
